PHASE I INSPECTION REPORT
NATIONAL DAM SAFETY PROGRAM

**HANSON CREEK DAM
LEWISTOWN, MONTANA
FERGUS COUNTY
MT 01570**

**HKM ASSOCIATES
BILLINGS, MONTANA**

MARCH 1981

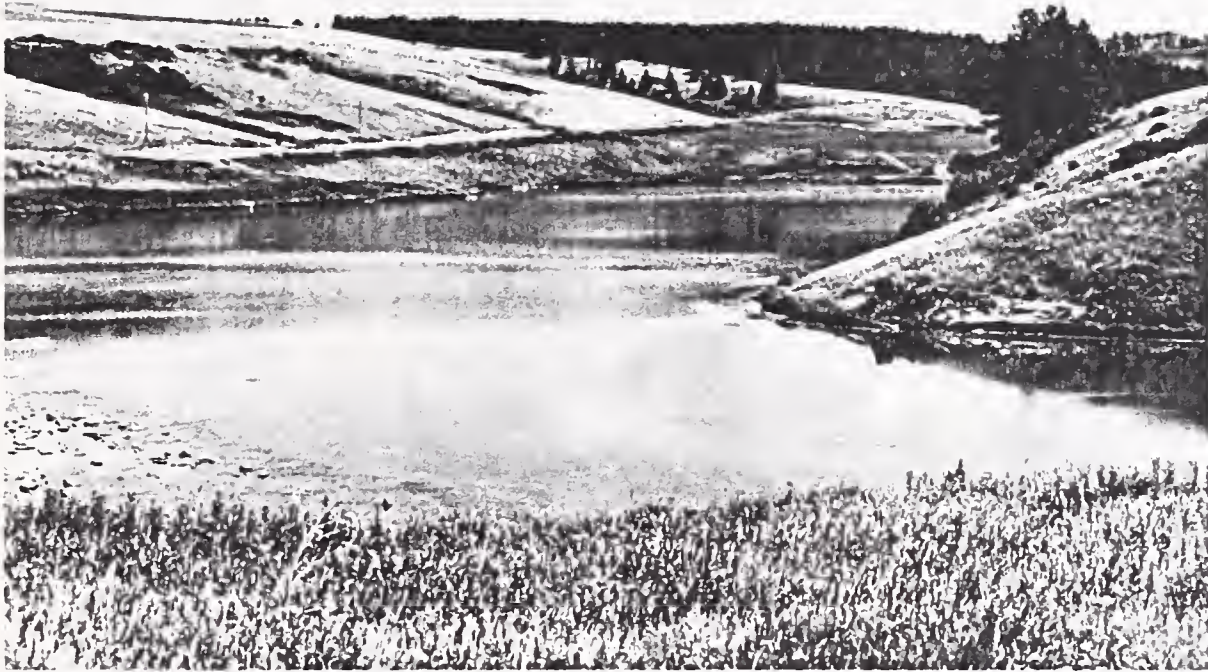
PHOTO NO. 1 - Hanson Creek Reservoir. Standing on embankment near emergency spillway entrance, looking upstream into the basin.

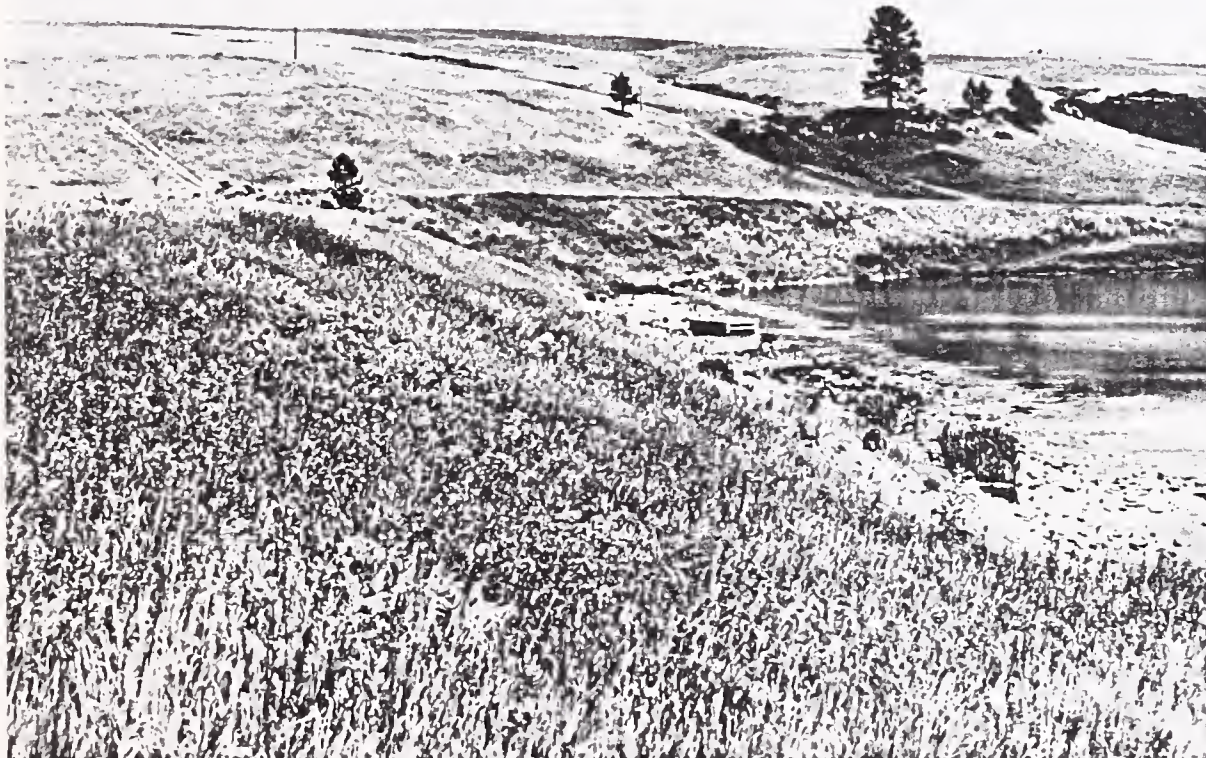
The embankment structure appears to be in good condition with only minor sloughing of the topsoil at isolated locations on the downstream slope. The seepage control system was satisfactorily accommodating the underseepage at the time of the field investigation. The minimum calculated factor of safety for the steady state condition is below the recommended guidelines. There are no piezometers in the embankment to verify the location of the phreatic surface through the dam. Debris and plant growth was observed on the upstream face.

PHOTO NO. 2 - Upstream embankment face. Notice vegetation above rock riprap. Also note vegetation in rock area.

Immediately develop, implement, and test an emergency downstream warning plan for use in the event of dam distress. Inspect the 24-inch conduit as soon as possible, and repair as required. Provide emergency closure capability of the emergency spillway conduit at the riser. Inspect periodically, and repair areas on the embankment slopes that have experienced topsoil sloughing. Periodically remove large debris from the upstream face and in the immediate vicinity of the principal spillway riser. Repair the concrete deterioration of the outlet structure, and replace the sealant material where the pipe exits into the structure. Periodically inspect the riprap protection blanket on the upstream face for zones of rapid deterioration. On the upstream face, remove plant growth in the riprap section, and add and/or rearrange the rock to cover deficient areas.

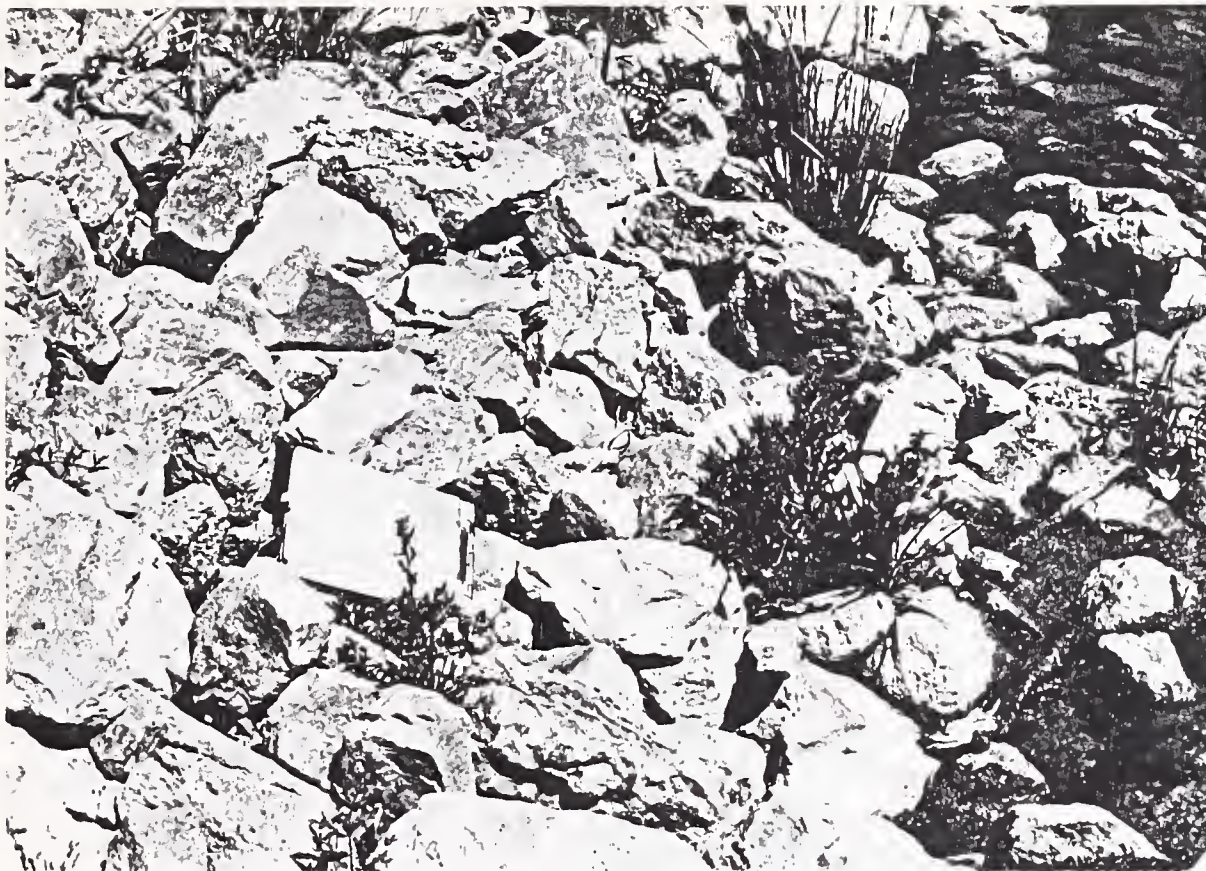
The riprap material on the upstream face of the dam and on the banks of the downstream channel below the impact basin (outlet structure) consists of calcareous sandstone and limestone. This material is erosion resistant and appears to be performing adequately. Some debris accumulation was observed on the riprap face particularly near the principal spillway inlet. Cattails and other plants are growing in the riprap on the upstream slope. Additional rock riprap material, placed in deficient areas, would enhance the protection and discourage plant growth. Photos 2 and 3 of Appendix C provide a photo-view of riprap conditions on the upstream face.

PHOTO NO. 3 - Rock riprap on upstream face. Classification: calcareous sandstone and limestone.

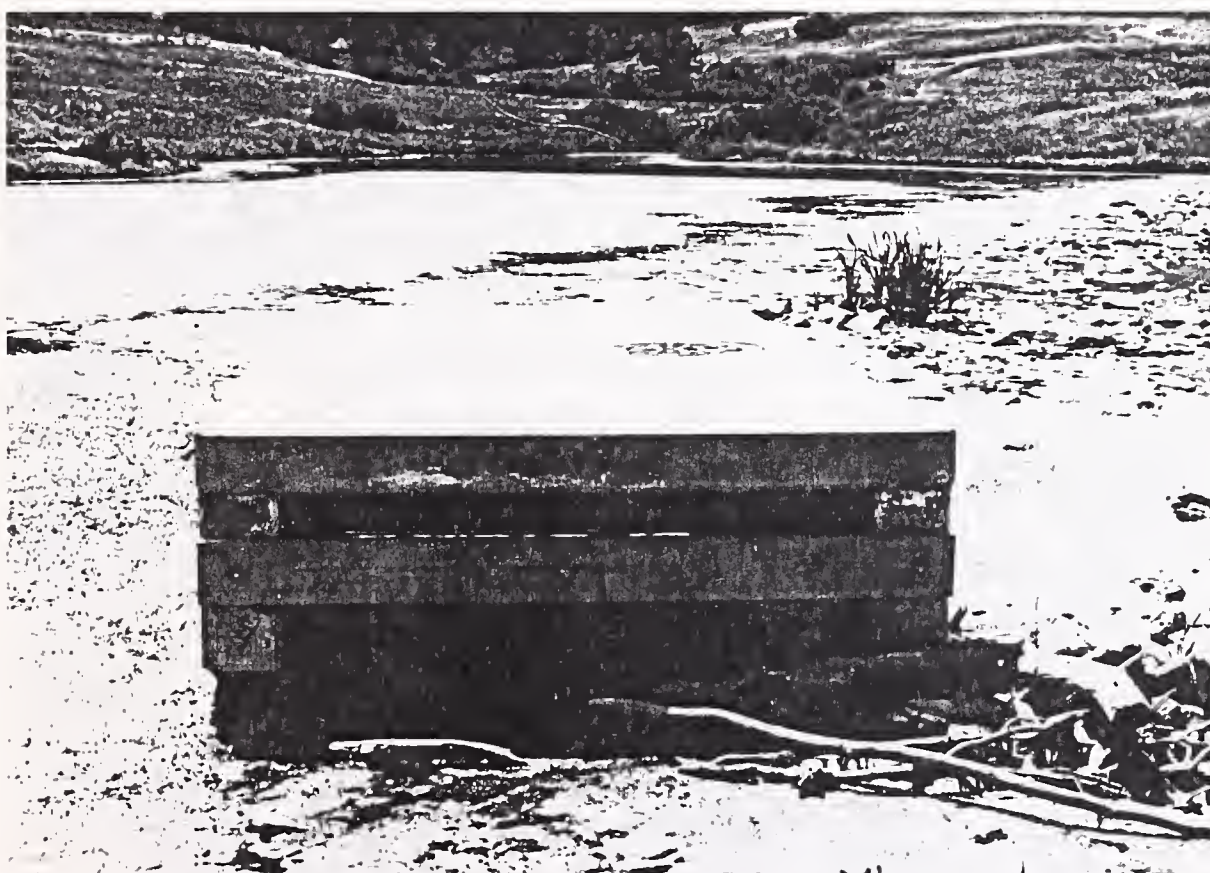
There was a small amount of water entering the spillway riser and passing through the conduit at the time of the inspection. No major structural or operating problems were evident at this reservoir level. Minor concrete deterioration was noted on the impact basin (outlet structure). Some debris is collecting at the riser (Photo 4 of Appendix C). The return channel appeared to be stable and in good operating condition (Photo 7 of Appendix C). The return channel is constructed on a very flat gradient, but does not appear to be adversely impacting the hydraulics of the system.

PHOTO NO. 4 - Principal spillway, two-sided inlet with cover. Notice debris accumulation. Emergency spillway inlet in upper right corner of picture.

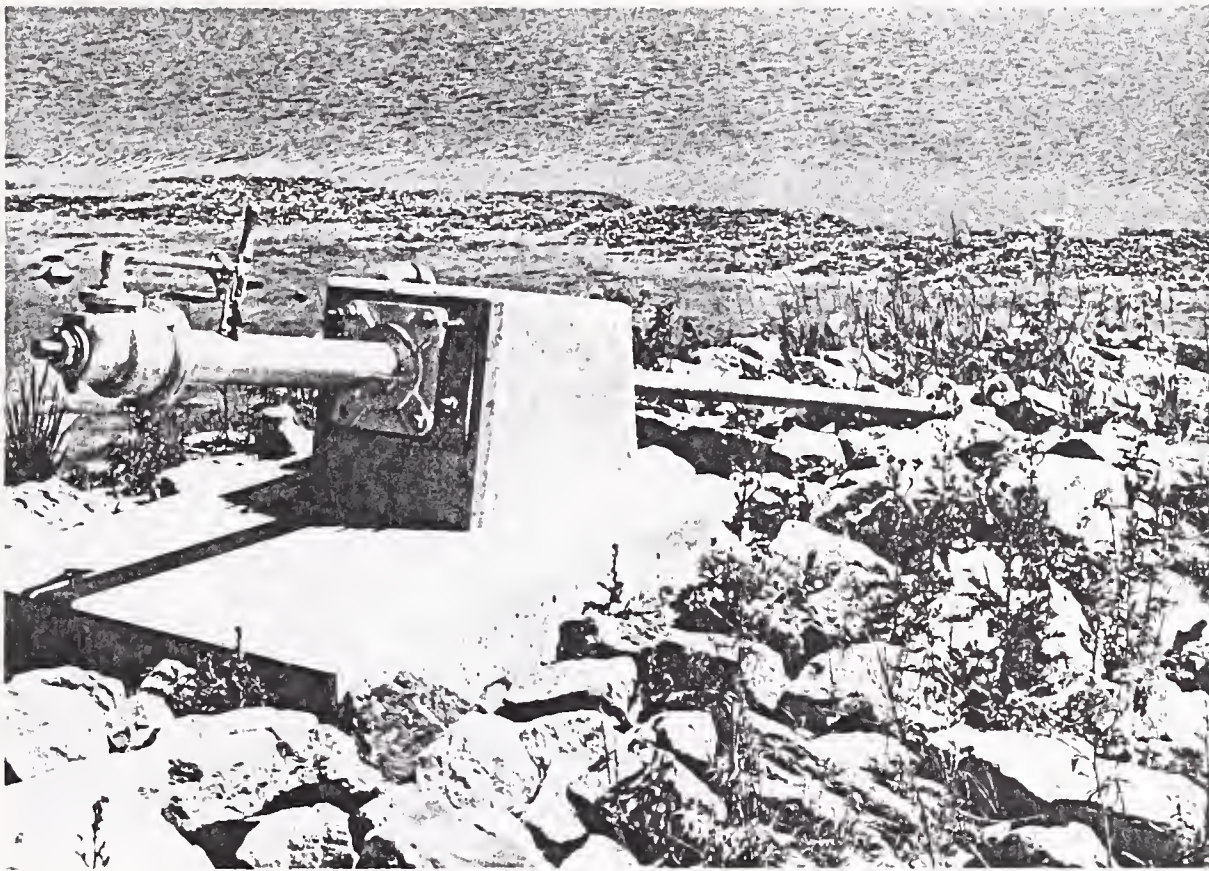
All elements specific to the outlet works which were inspected appear to be in satisfactory operating condition. The gate was partially opened during the inspection, and the low-level outlet system was operated for a short period of time. Inspection of the conduit and gate was not possible due to the height of the reservoir pool at the time of the field inspection. Refer to Section 2.1.1 for the assessment of physical conditions relative to the impact basin and return channel.

PHOTO NO. 5 - Manual operator for low-level outlet. Also shown are the gate stem, air vent, and concrete pedestal.

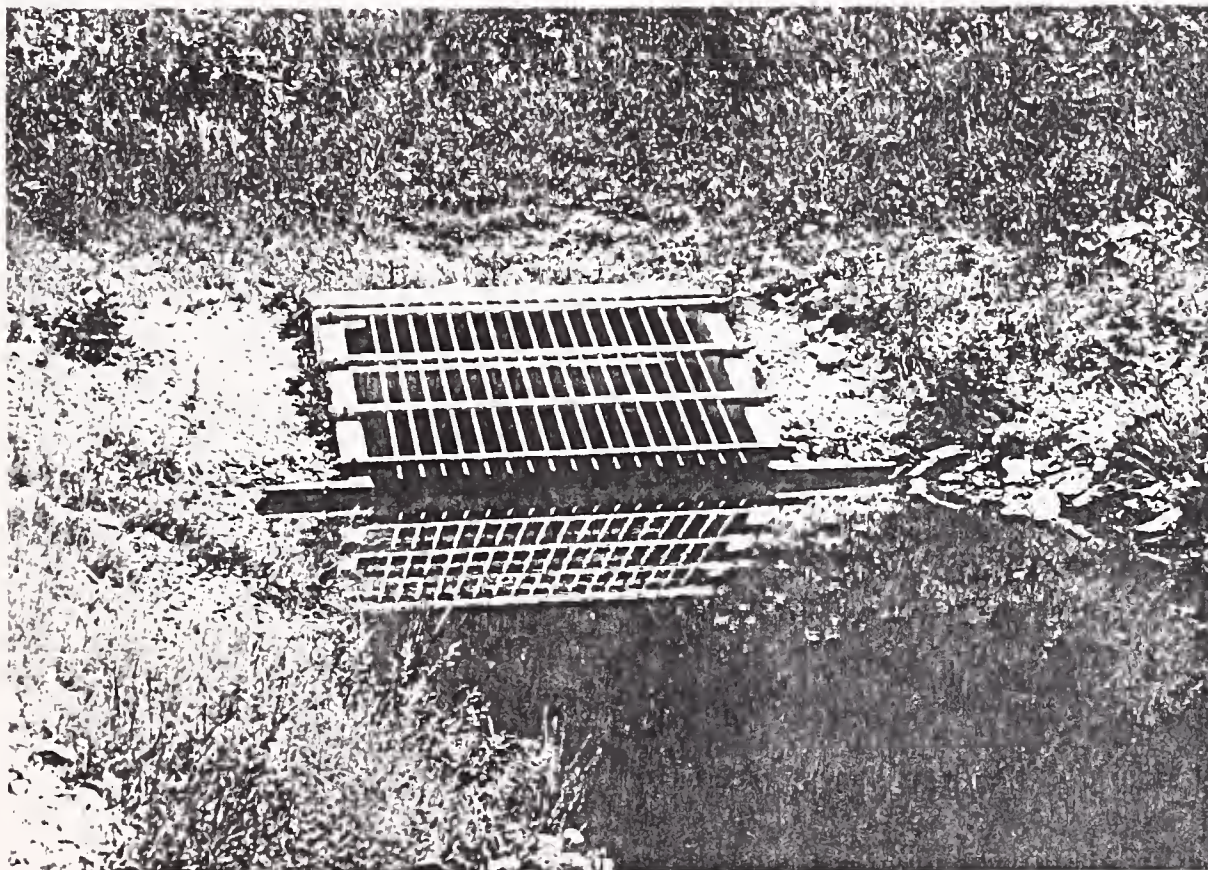
PHOTO NO. 6 - Outlet structure. Standing on right bank looking upstream at outlet structure/energy dissipator.

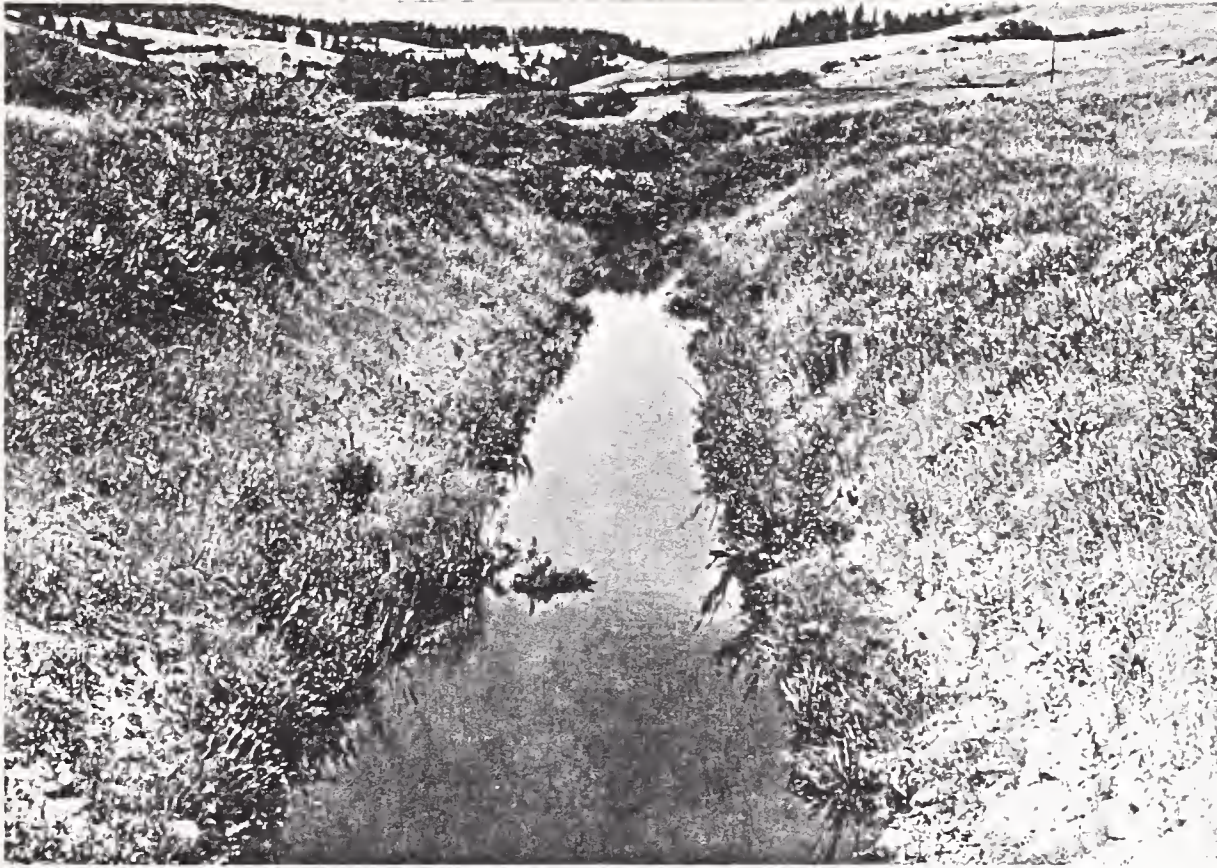
PHOTO NO. 7 - Hanson Creek return channel. Standing on outlet structure looking downstream.

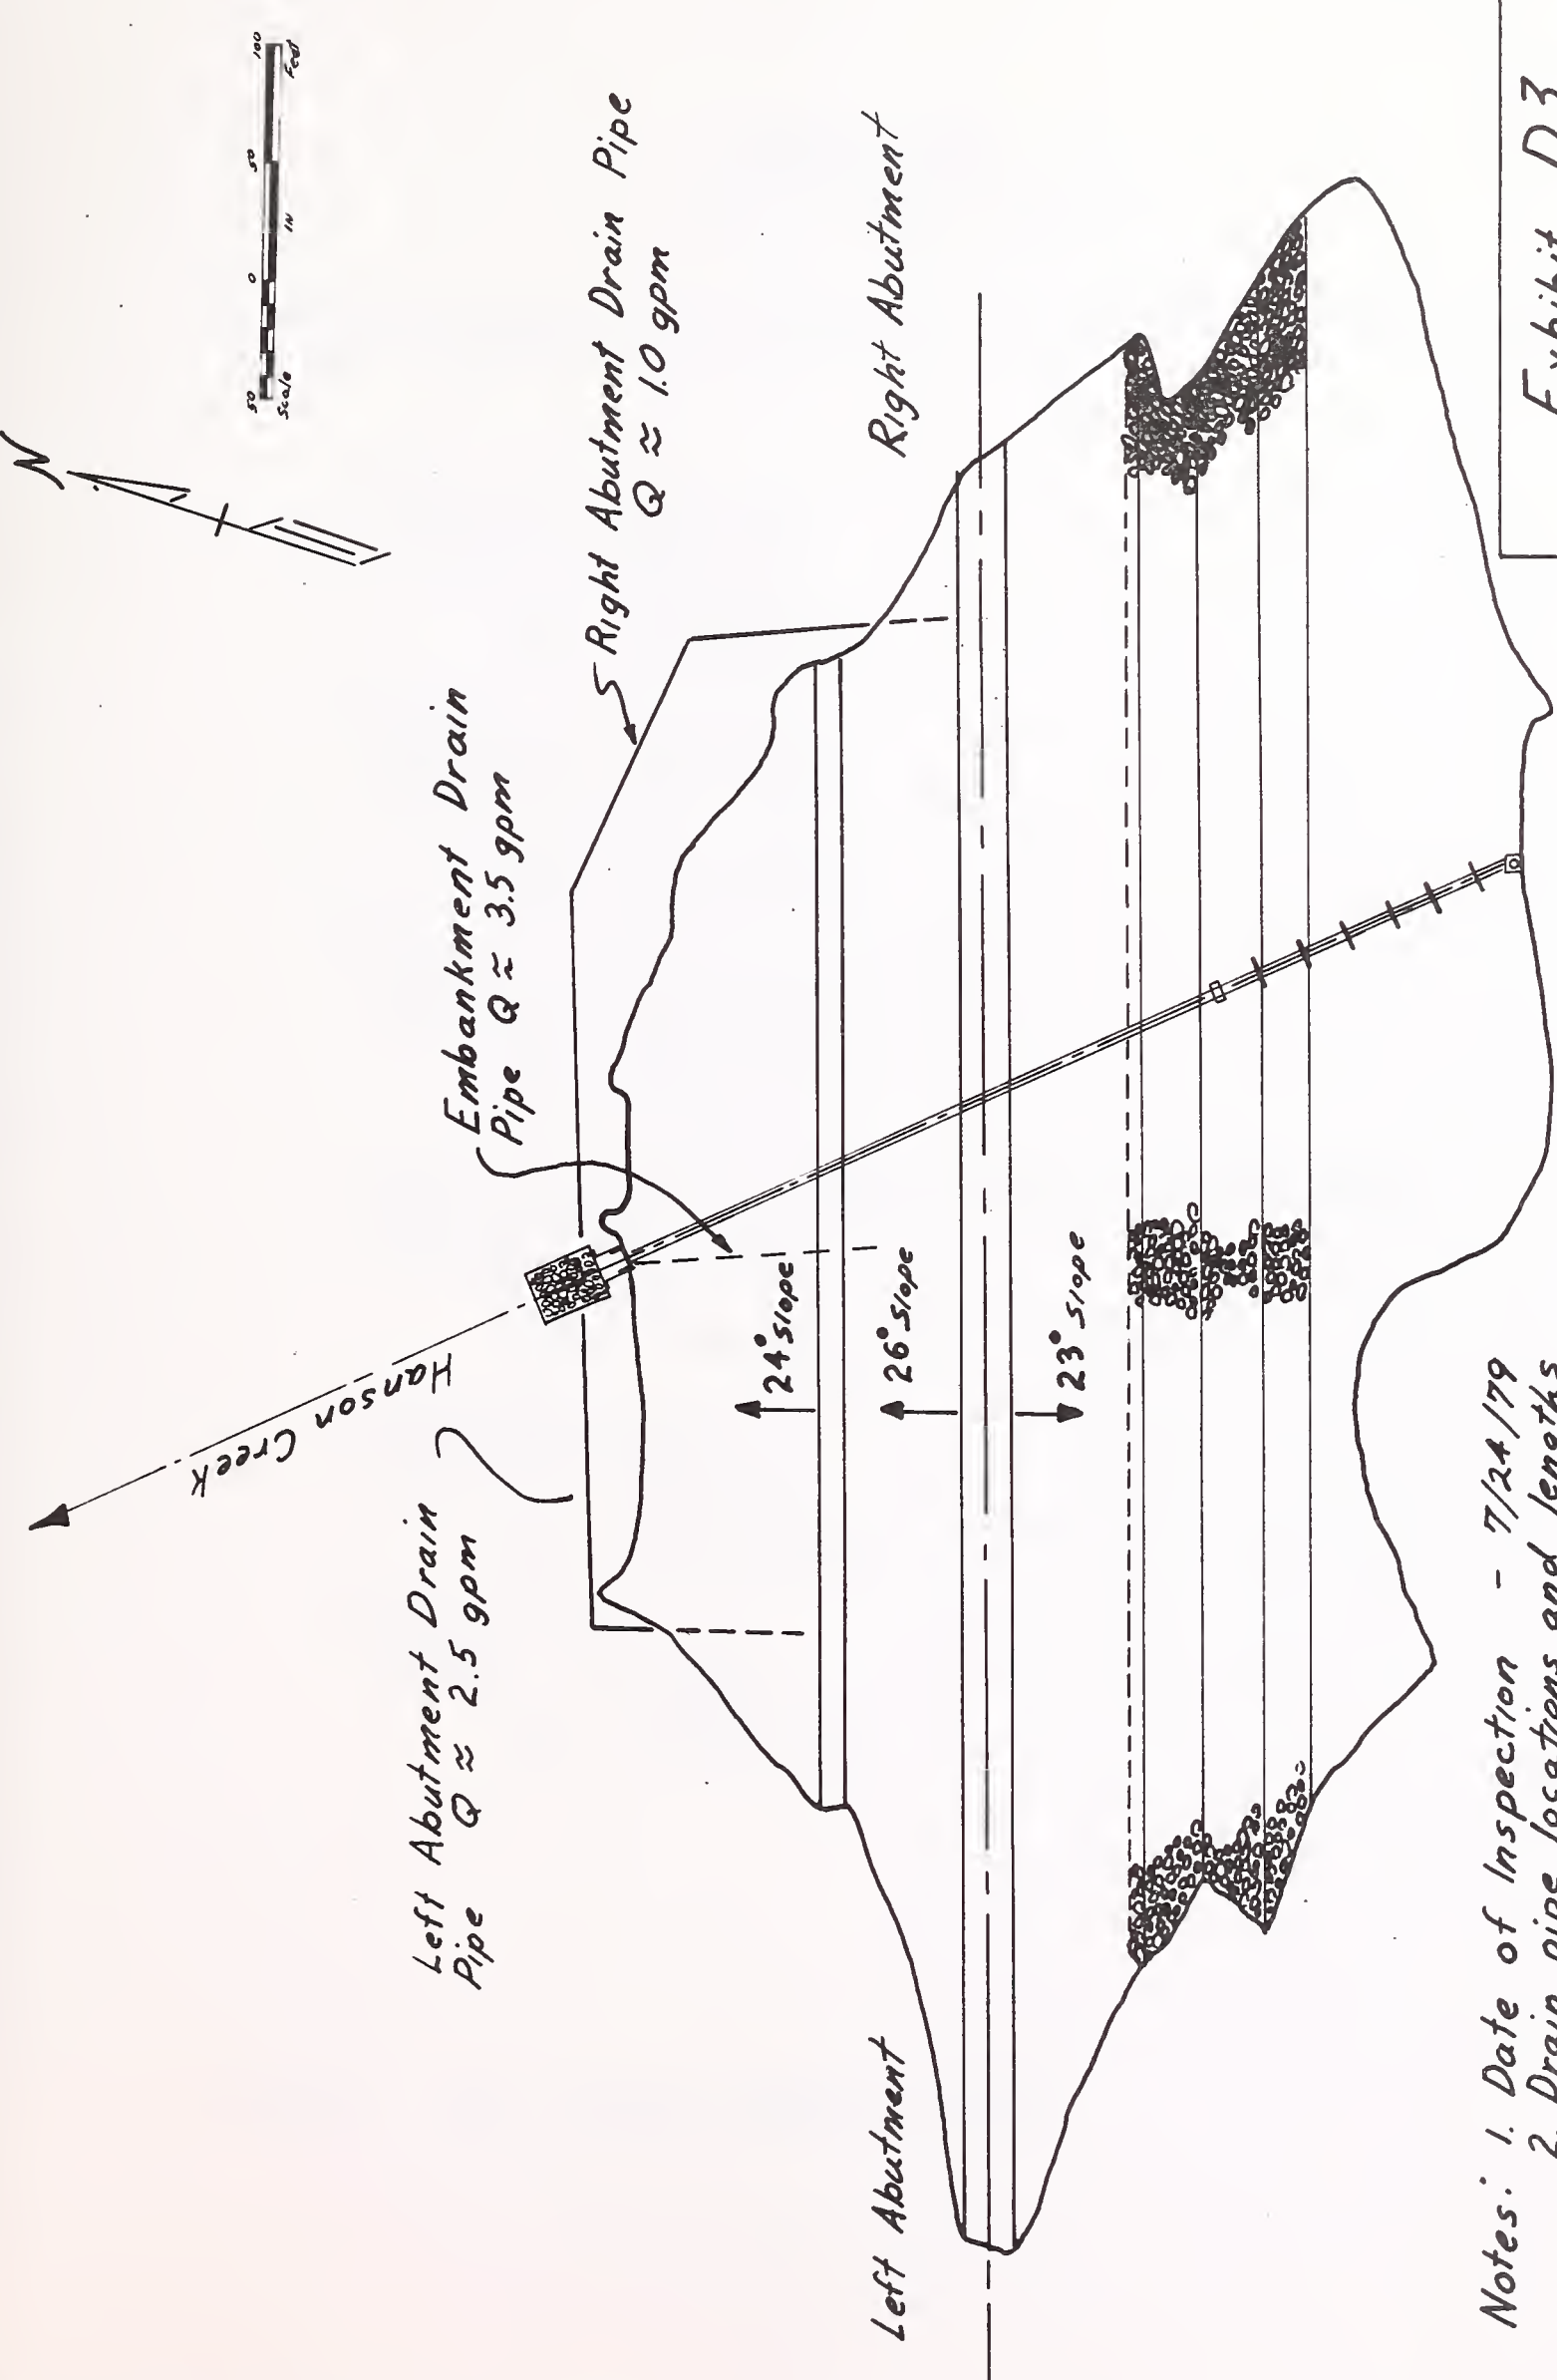
Exhibit D3
 Measured Embankment
 Slopes Hanson Creek
 Dam
 HKM Assoc. 7M140.103

Slope angles were measured during the field investigation and the results are shown in Exhibit D3 of Appendix D. The slope angles were measured with an Abney level and should be considered approximate. It should be noted from the exhibit that the upstream slopes appear slightly steeper than designed. This is probably due to spillover of topsoil which was being placed to obtain desired overbuild.
